## Contamination Overview Study

Yonge Subway Extension Project  
Train Storage Facility  
Environmental Project Report Addendum  
High Tech Road to Oak Avenue,  
Richmond Hill, Ontario

Prepared For: Toronto Transit Commission  
and York Region Rapid Transit Corporation  
Project No: 3277670

July 2014

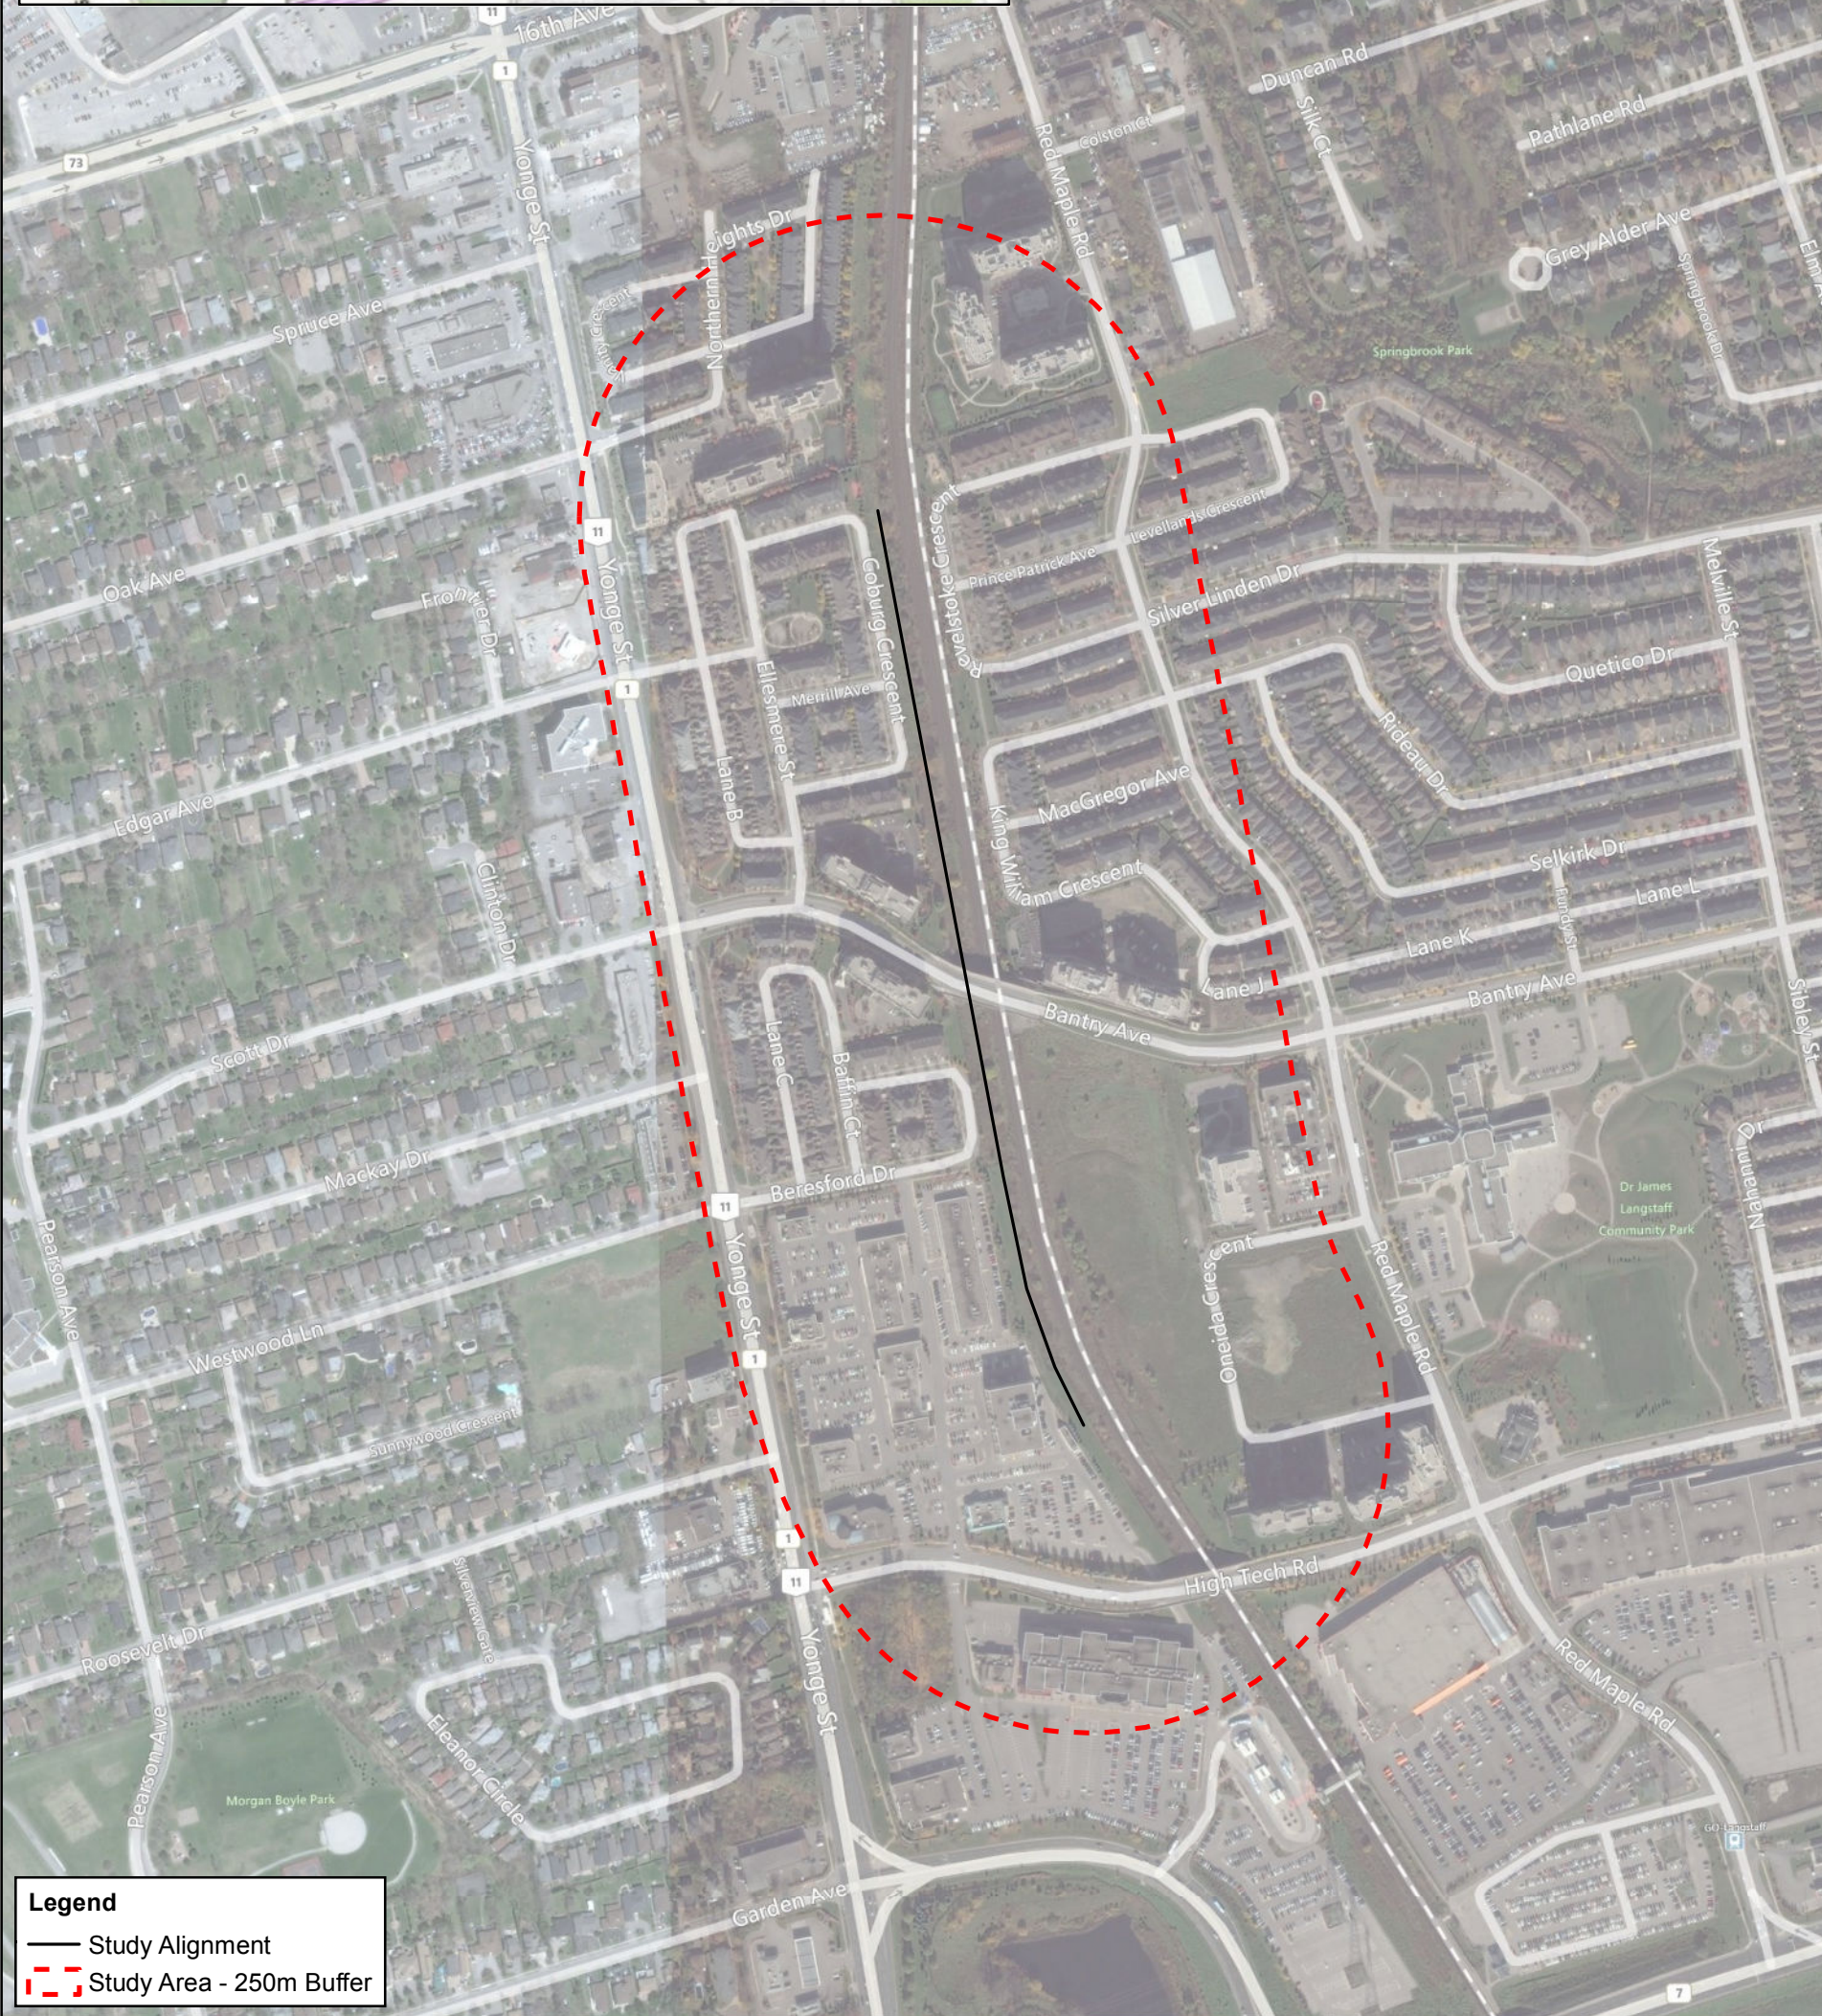
FIGURE  
 1

Current land use within the Study Area is predominantly residential and commercial. Low-density with occasional high-density residential land use is present primarily in the central and northern portions of the Study Area, to the north of Beresford Drive and Bantry Road. Commercial land use is present as businesses in the southwestern portion and along the western boundary of the Study Area. Medical offices can be found in the southeastern portion of the Study Area. Office buildings are present in the southwestern portion of the Study Area. Land uses surrounding the Study Area are shown in **Figure 1**.

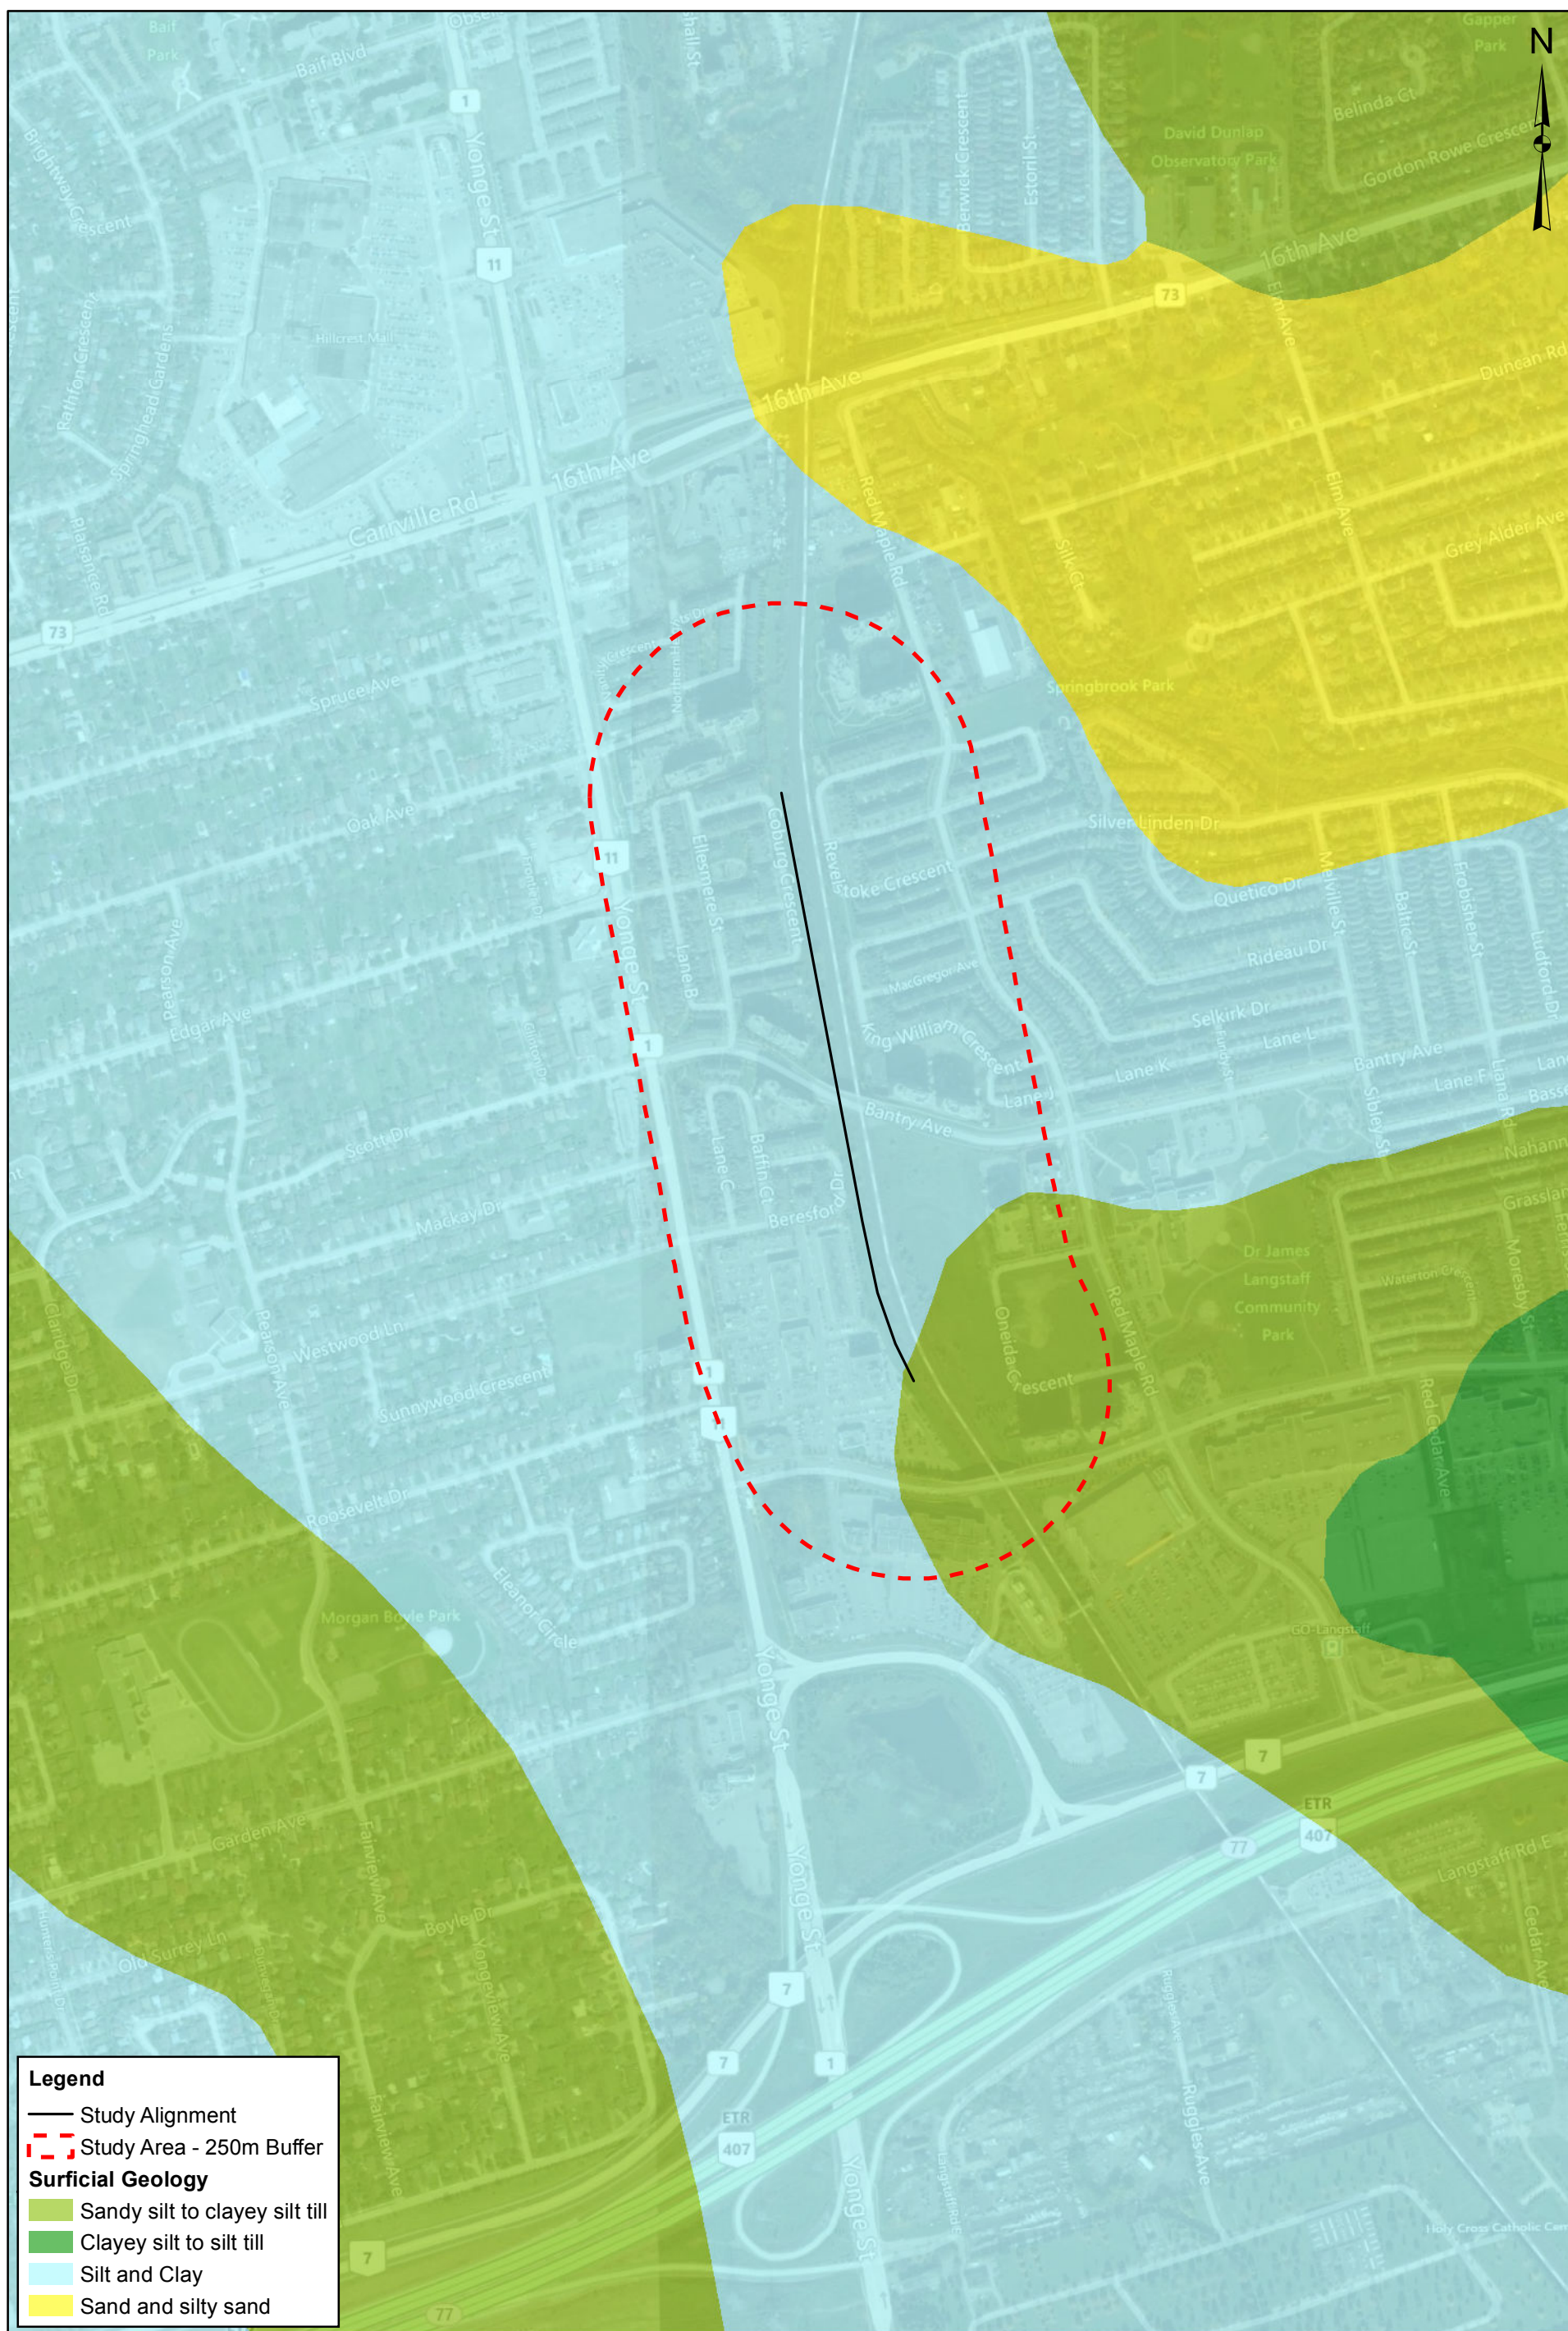
**SURFICIAL GEOLOGY**

- Study Alignment
- - - Study Area - 250m Buffer
- Surficial Geology**
- Light Green: Sandy silt to clayey silt till
- Medium Green: Clayey silt to silt till
- Light Blue: Silt and Clay
- Yellow: Sand and silty sand

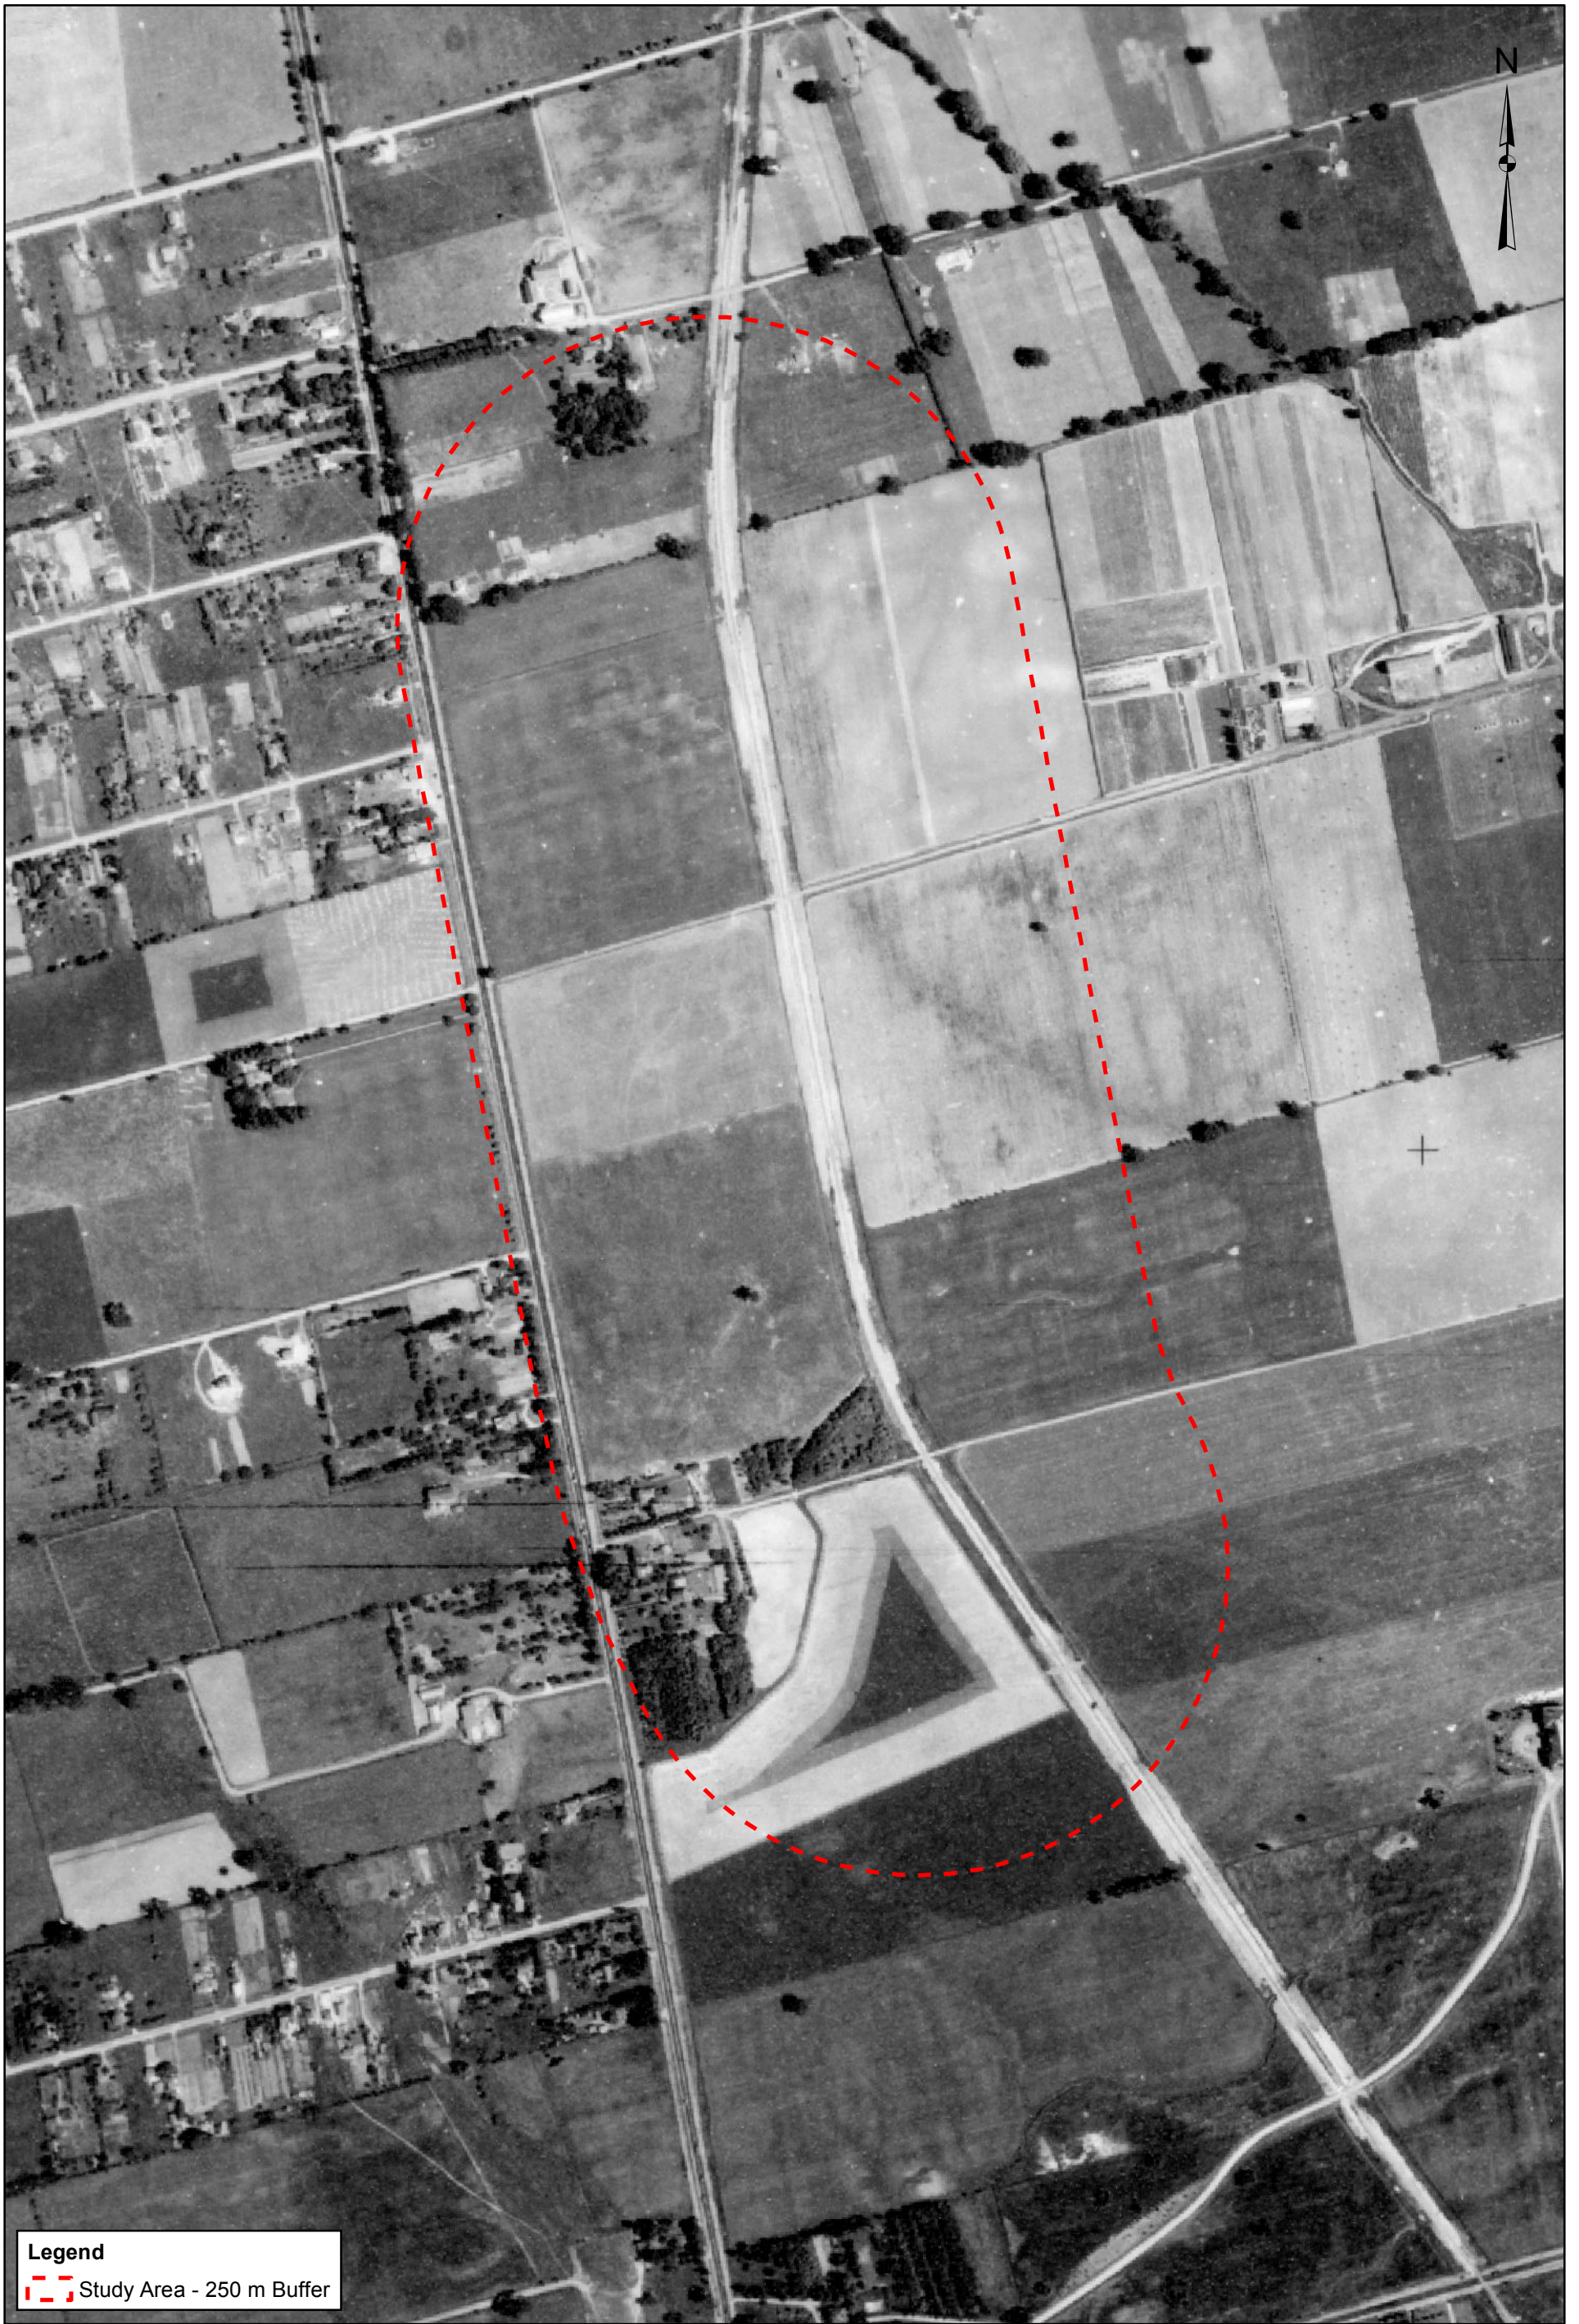
**A-1**

- In the 1960 air photo, new residential and commercial developments can be observed to the west of Yonge Street and in the northern portion of the Study Area. The rest of areas remained largely vacant and/or agricultural. A tributary of the East Don River is interpreted to be flowing from northwest to southeast, to the west of the Study Area.
